SEATTLE CITY LIGHT WORK ORDER #89-6
1989 AUTUMN MONITORING OF THE GEORGETOWN FLUME

RAVEN SERVICES CORPORATION
2200 SIXTH AVENUE, SUITE 519
SEATTLE, WASHINGTON 98121
(206) 443-1126; FAX (206) 443-1128

October 30, 1989

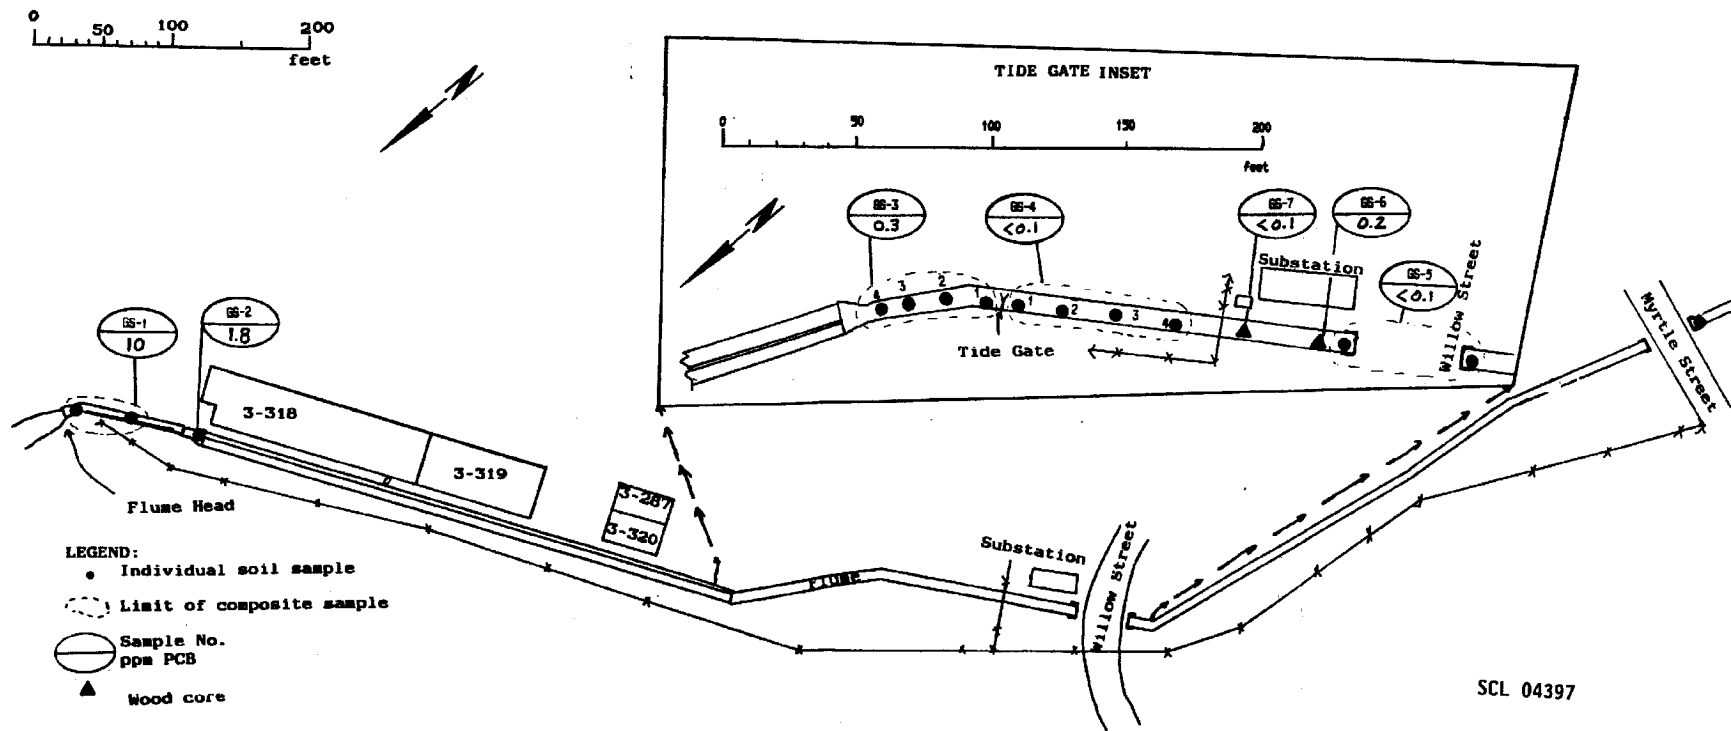
SCL GEORGETOWN FLUME SYSTEM
AUTUMN TESTING - 1989

Wood cores were specified for this project. Raven has devised a corer that can sample any of the wood floor locations. The corer consists of a steel punch, 5/8" in diameter and nine feet long. Threads at the bottom of the punch allowed the corer to be screwed out from the planks after it had been hammered in. Sampling locations are shown in the Figure.
